Monitoring Series No. ME-09-MSTY-0797-1

THREE-YEAR COMPREHENSIVE MONITORING REPORT

**CAMERON PRAIRIE REFUGE PROTECTION  
ME-09**

**First Priority List Shoreline Protection Project  
of the Coastal Wetlands Planning, Protection, and Restoration Act  
(Public Law 101-646)**

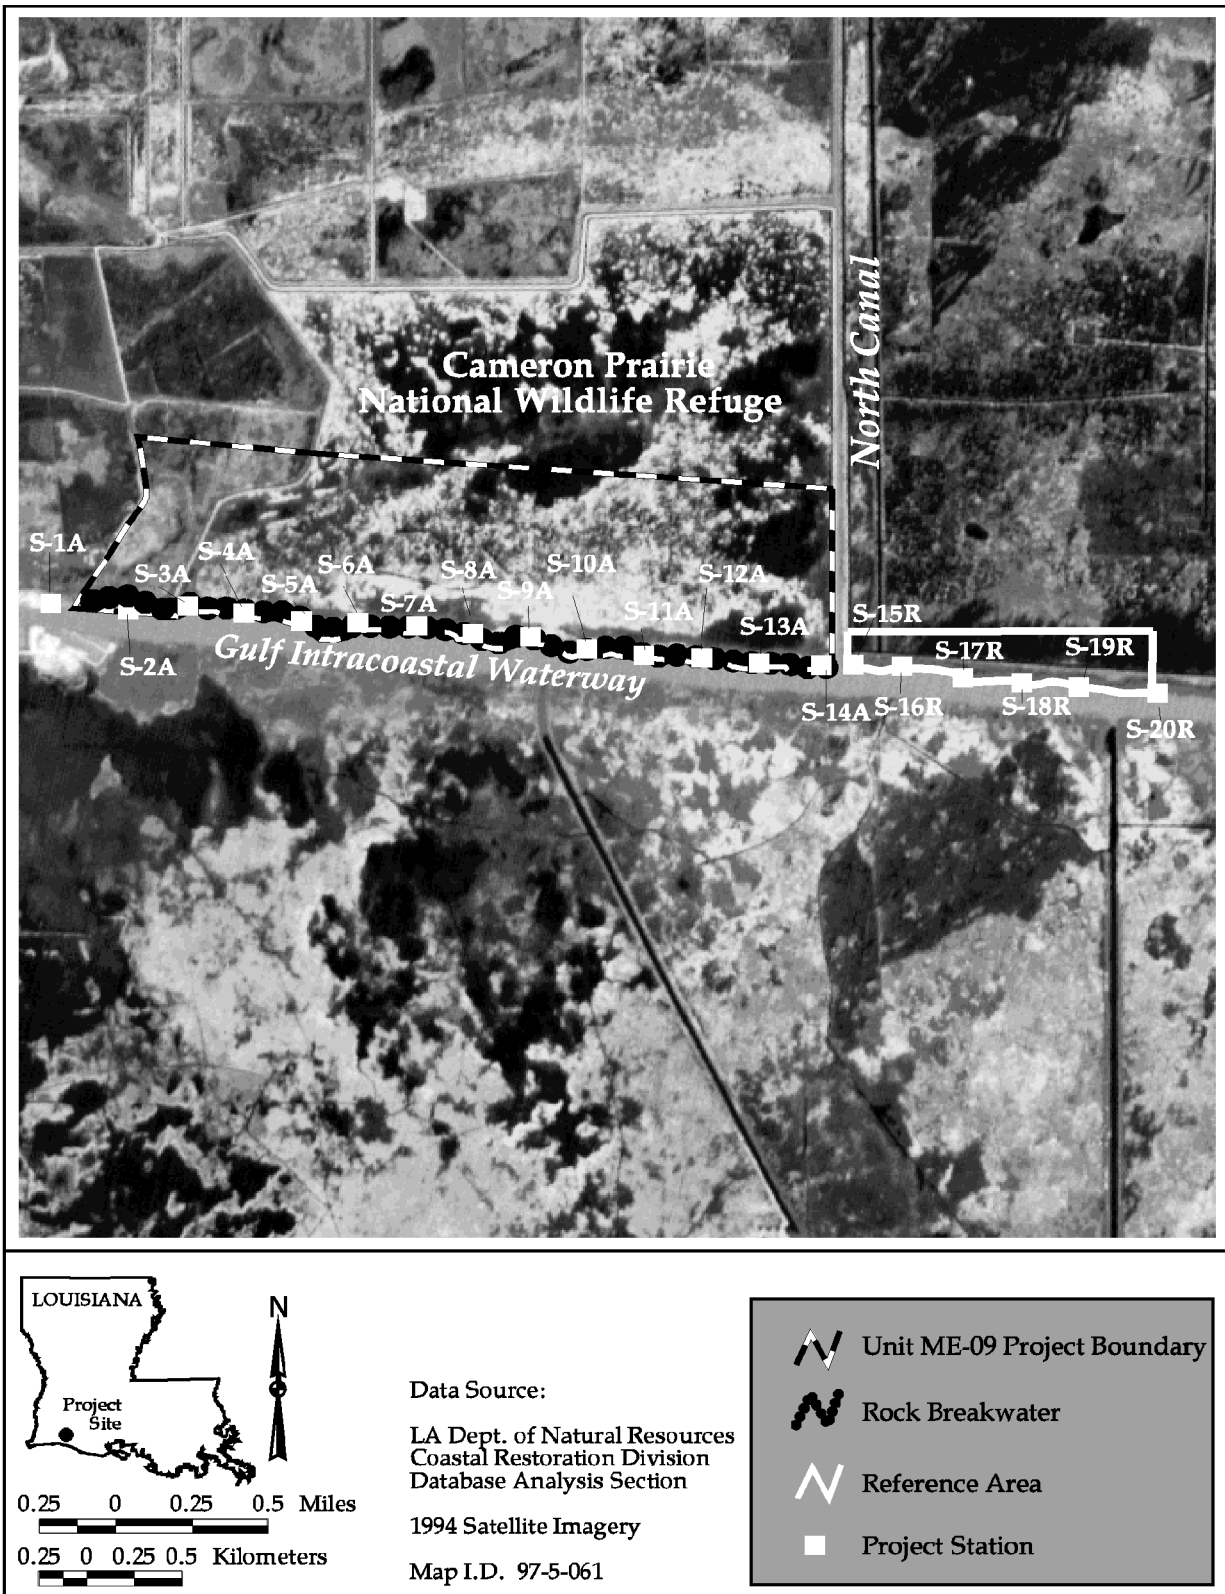
**Figure 1.** Cameron Prairie Refuge Protection (ME-09) project boundaries and features.

The Cameron Prairie Refuge Protection (ME-09) project is located in north-central Cameron Parish within the Cameron Prairie National Wildlife Refuge (figure 1) and encompasses 350 ac (140 ha) of highly organic freshwater wetlands (USFWS 1991). The GIWW borders the project area to the south and threatens to breach into the refuge. Wave action caused by boat traffic within the GIWW has eroded most of the spoil banks that protect the refuge, allowing the high energy saline waters of the GIWW to enter the project area. The resulting wave energy and saltwater intrusion has impacted the fragile interior freshwater wetlands, and could potentially result in a “blowout”, causing considerable wetland loss (Cameron Prairie National Wildlife Refuge 1991).

The project design consists of installing a rock dike (breakwater) to protect the remaining shoreline. In August 1994, a 13,200 ft (4,023 m) rock breakwater was constructed 0-50 ft (0-15.24 m) from, and parallel to, the northern bank of the GIWW in 3 to 4 ft (0.9 to 1.2 m) of water. The purpose of the breakwater is to prevent the encroachment of the GIWW into the project area by preventing the waves caused by boat traffic from eroding the remaining spoil bank.

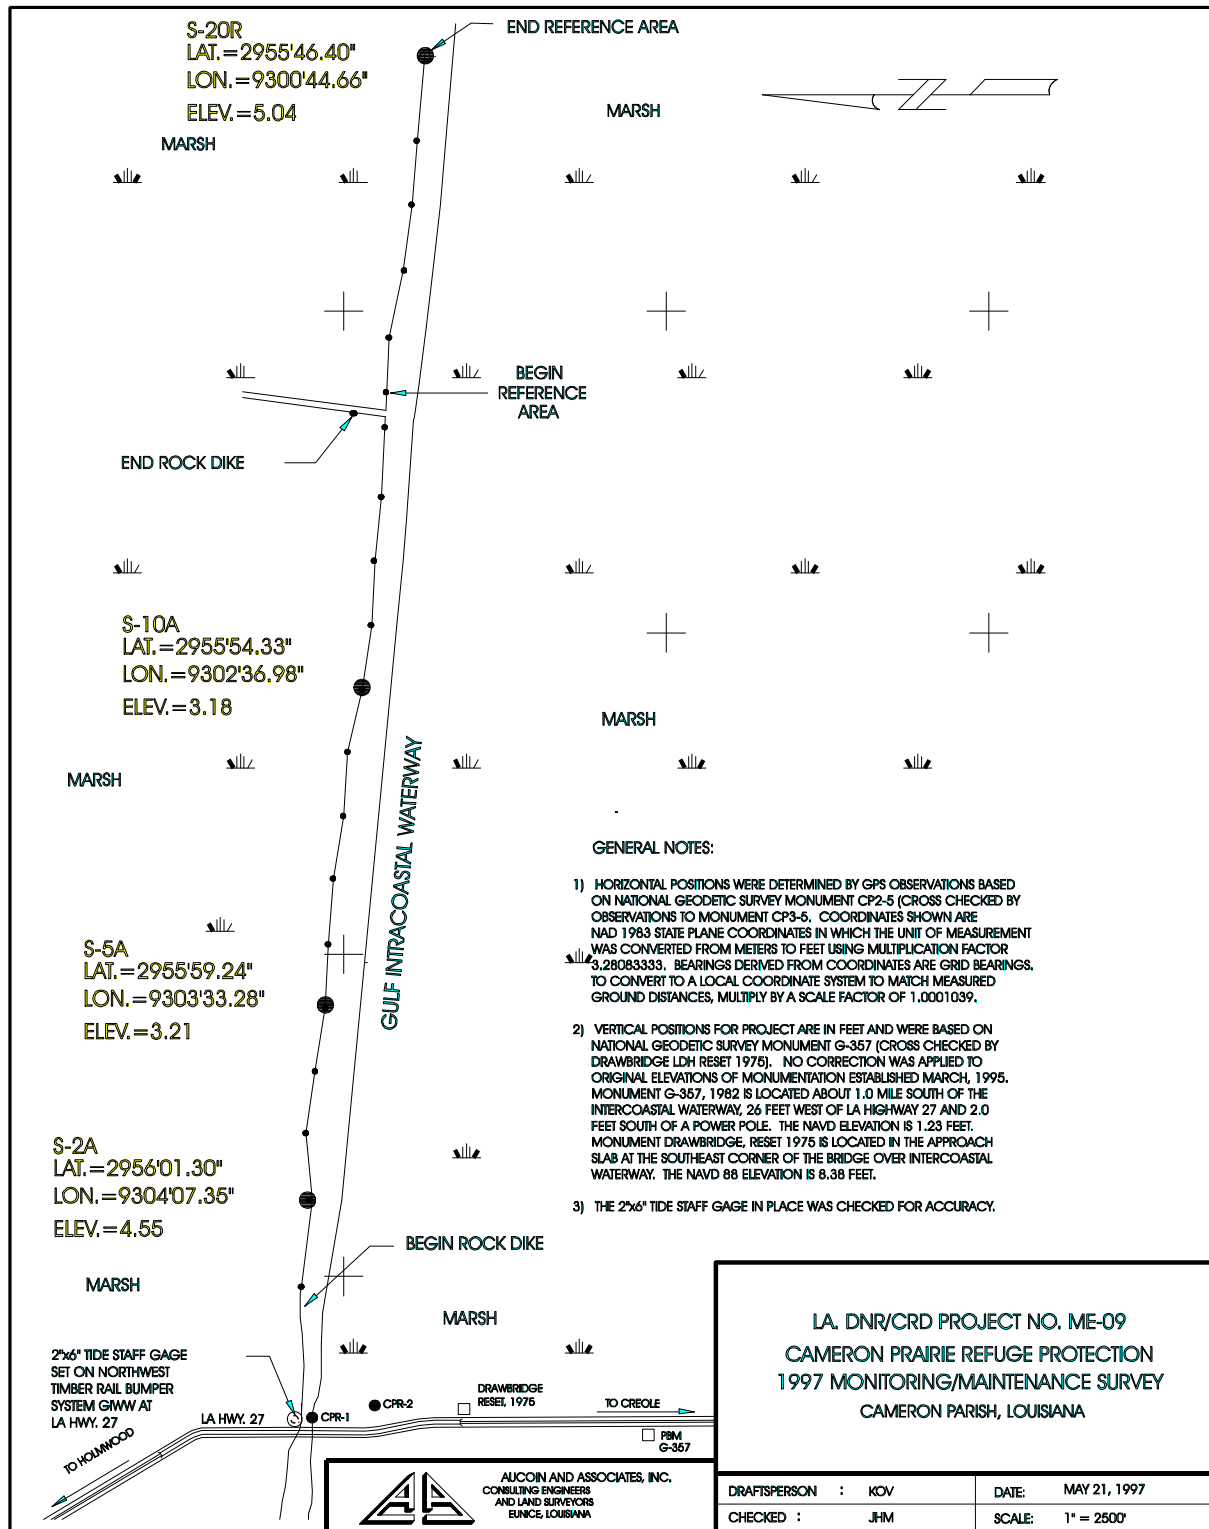
**Figure 2.** Cameron Prairie Refuge Protection (ME-09) plan view conducted by Aucoin and Associates, Inc. in 1997 showing each station in the project and reference area.

Cross-sectional surveys of the breakwater were completed in March 1995 and May 1997 (figure 2). The surveys delineated the vegetation edge, which will serve as our measure of shoreline position, and channel profile. This survey consisted of 20 cross-sections: 15 in the project area and 5 in the reference area. In the project area, the original brass hubs were all recovered in good condition. Due to erosion of the GIWW canal bank, the reference area brass hubs had to be reset on the proper azimuth away from the existing canal bank.

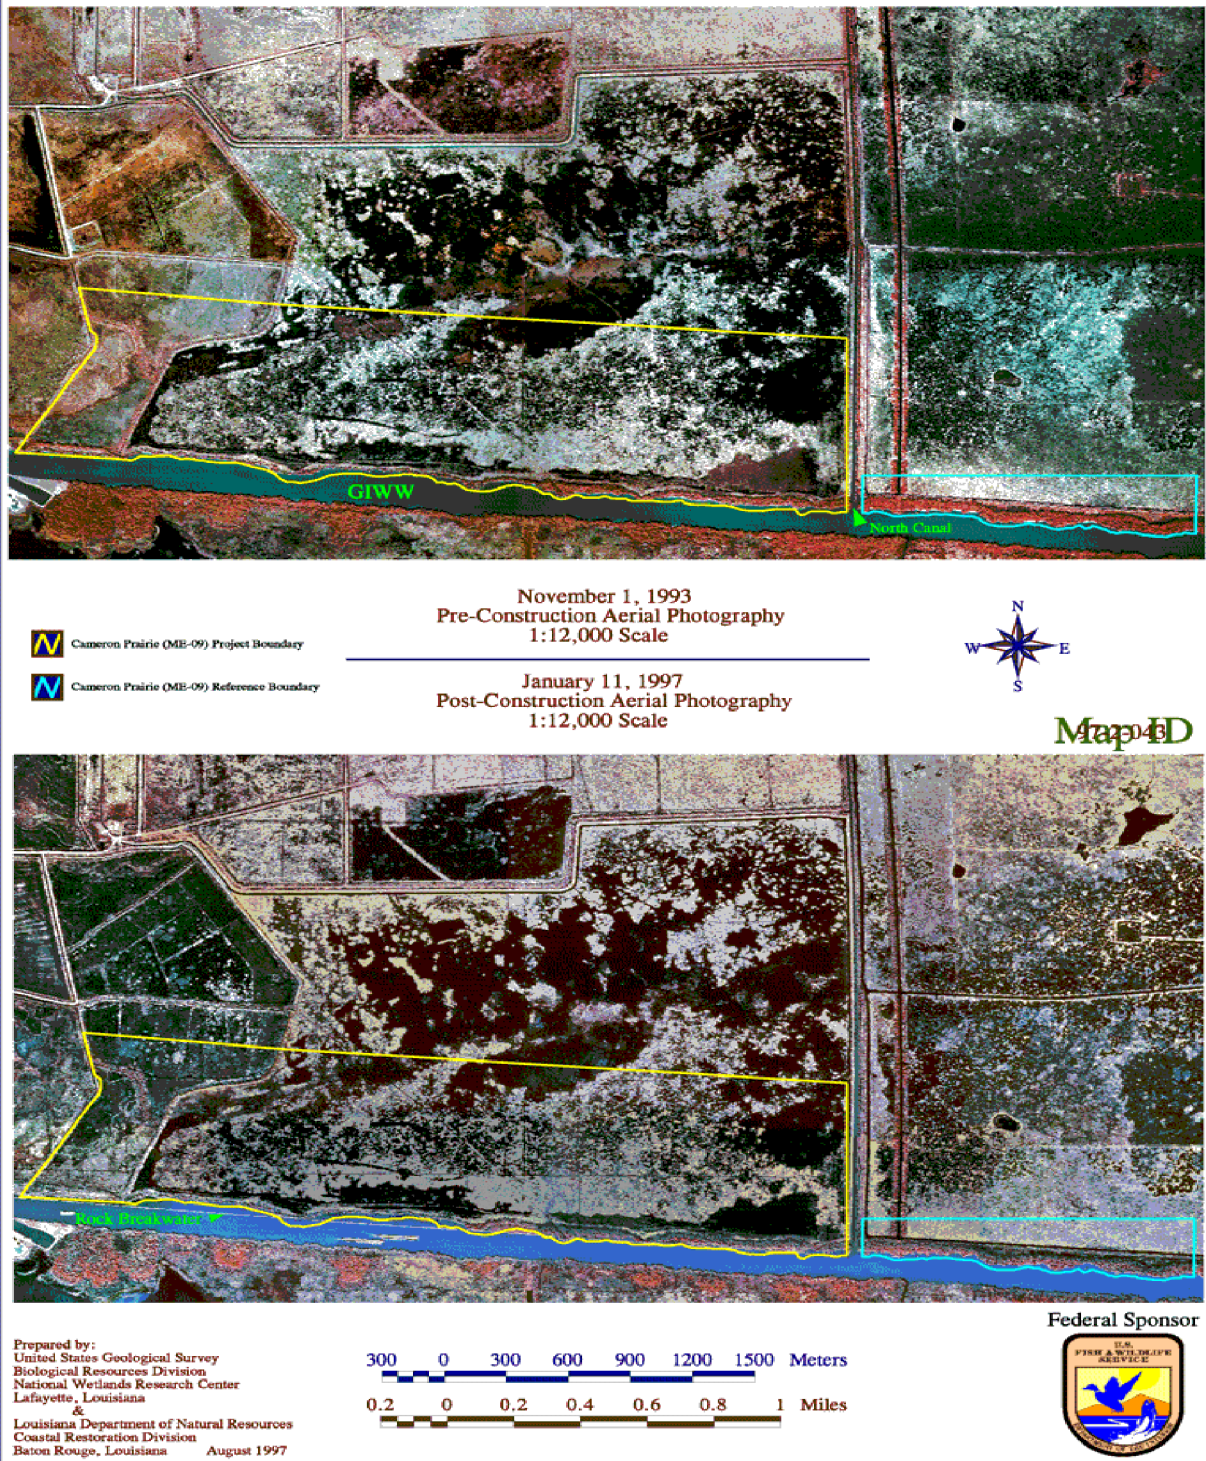
**Figure 3.** Cameron Prairie Refuge Protection (ME-09) pre- and post-construction aerial photography.

The GIS analysis revealed noticeable new vegetation present in the central portion of the project area, between the rock breakwater and the shoreline (figure 3). Overall, however, the 778 ac (315 ha) project area showed a 9.91% increase in water; by comparison, the 106 ac (43 ha) reference area experienced a 1.58% increase in water (table 1).

GIS land/water analysis comparing pre-construction and post-construction photography revealed only small changes in the reference area; whereas, the project area showed a marked increase in the ratio of water to land. However, four principal difficulties were associated with the interpretation of this photography. First, the western expansion section of the project area was eliminated from analysis due to standing water conditions and submersion of vegetation. Similar conditions may have contributed to the apparent increase in water in the analyzed portion of the project area as well. Second, the preconstruction photography, flown in November, showed trees and extremely high vegetation along the GIWW shoreline. This vegetation casts shadows which visually appear as open water on the photography. Third, the pre-construction photography showed large sections of floating vegetation throughout the project area and in canals in the reference area. On the photography, floating vegetation visually appears to be land. Finally, because the post-construction flight was conducted in January 1997, due to unsatisfactory weather conditions in November 1996, apparent differences in preconstruction and post-construction vegetation may be a reflection of time of year rather than project effects.

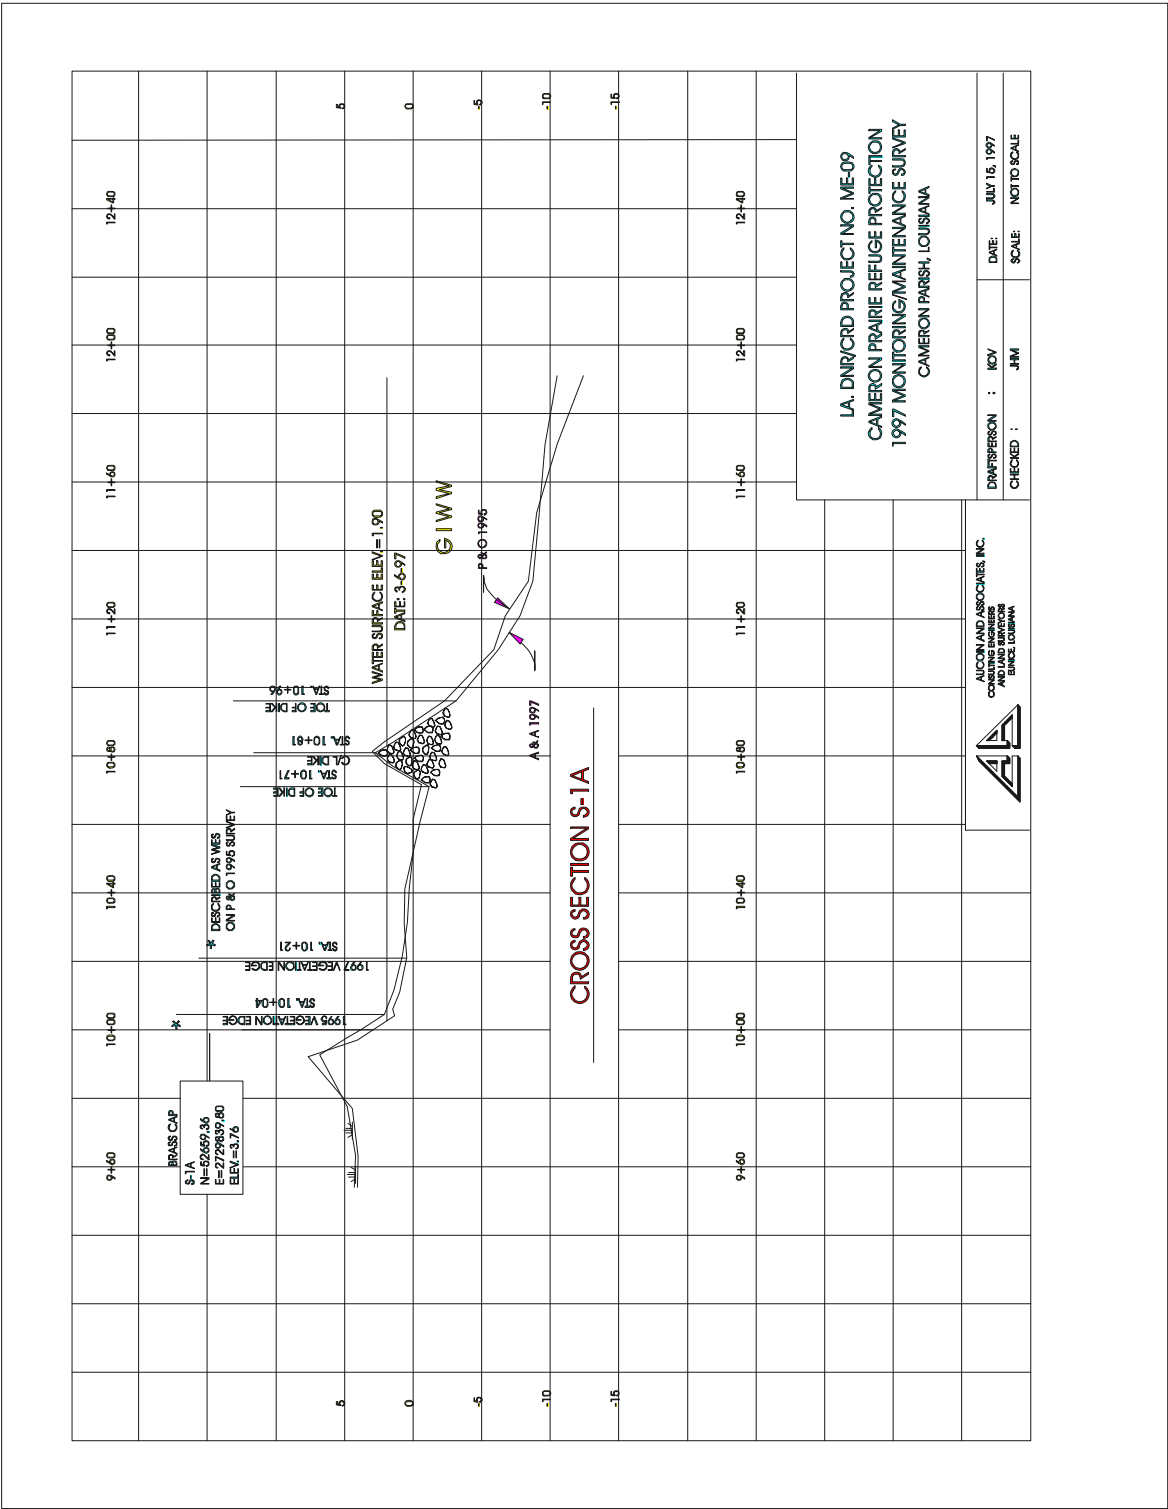
**Figure 4.** Cameron Prairie Refuge Protection (ME-09) cross section S-1A in the project area showing the survey lines, vegetation edge, and channel profile.

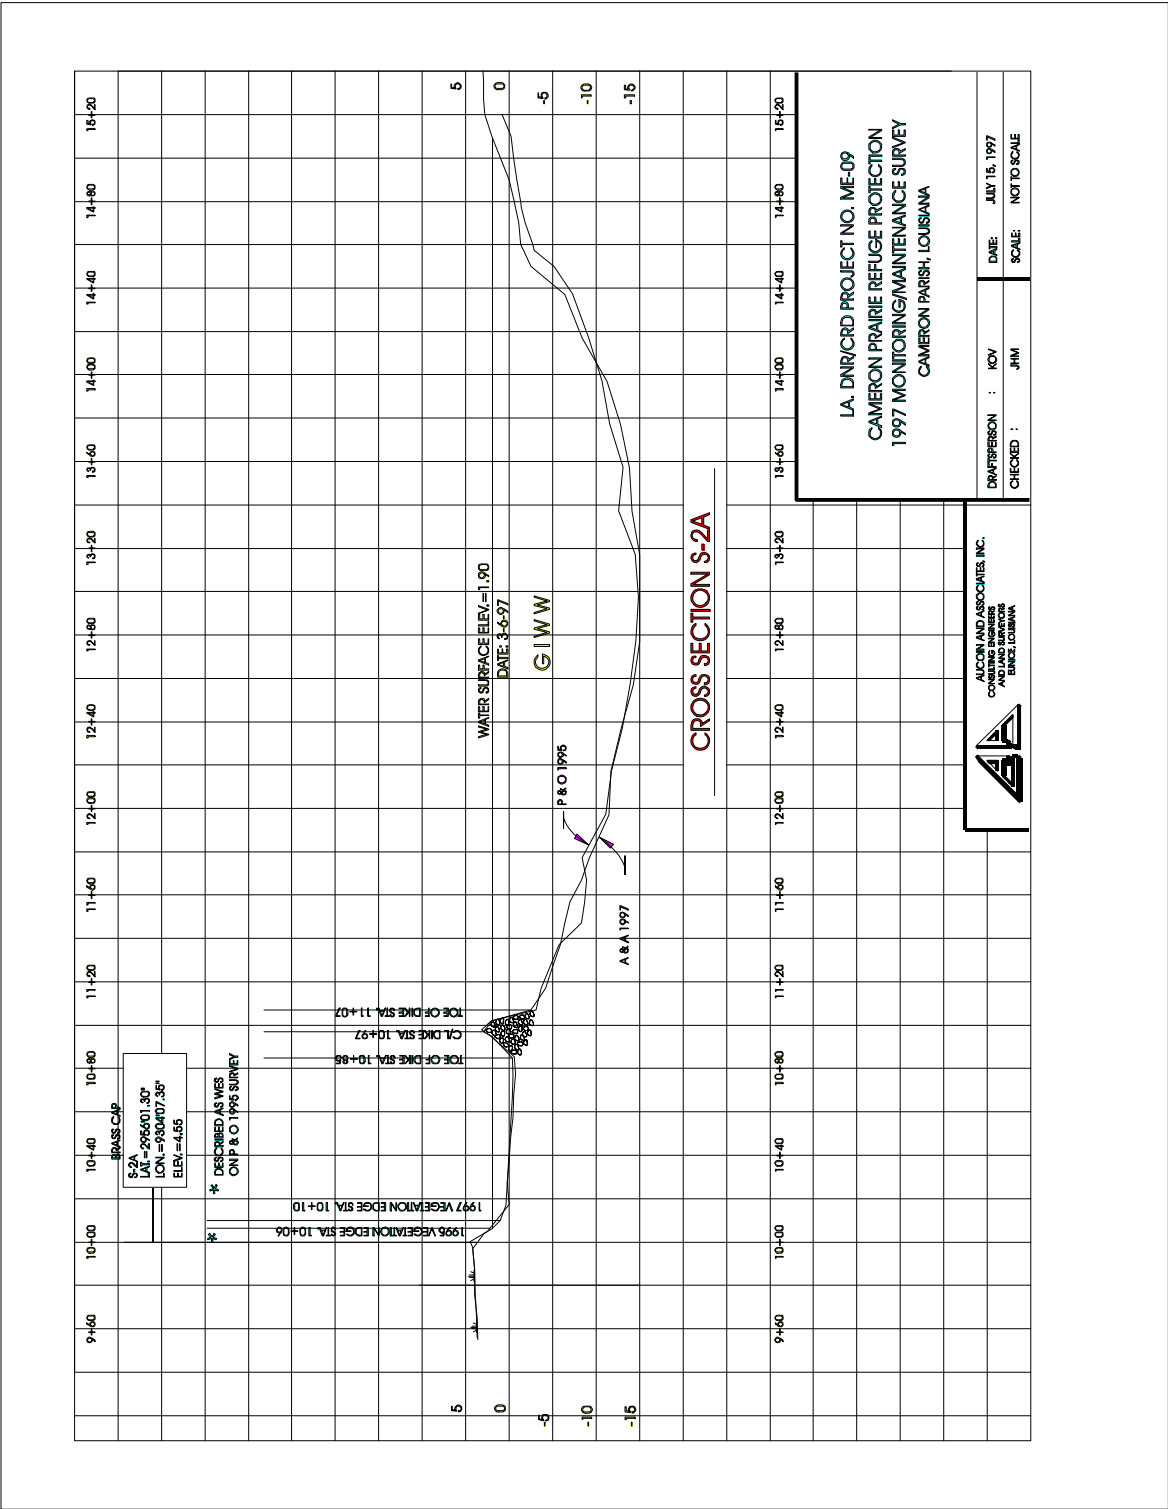
**Figure 5.** Cameron Prairie Refuge Protection (ME-09) cross section S-2A in the project area showing the survey lines, vegetation edge, and channel profile.

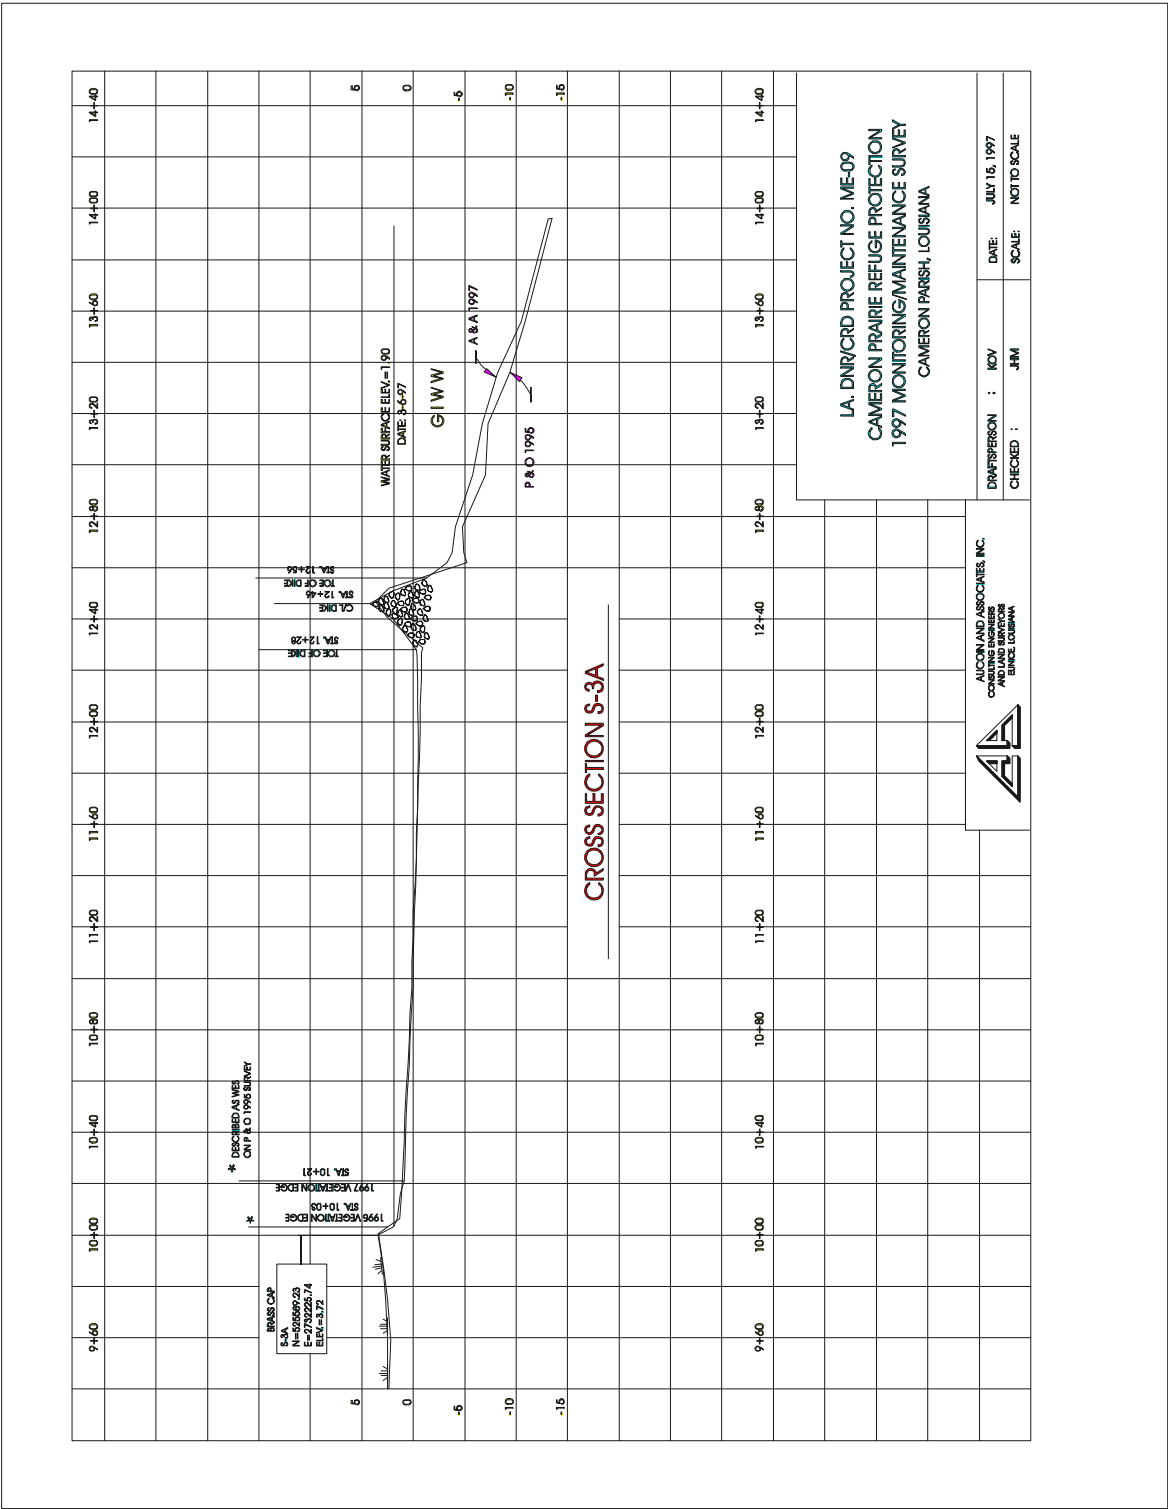
**Figure 6.** Cameron Prairie Refuge Protection (ME-09) cross section S-3A in the project area showing the survey lines, vegetation edge, and channel profile.

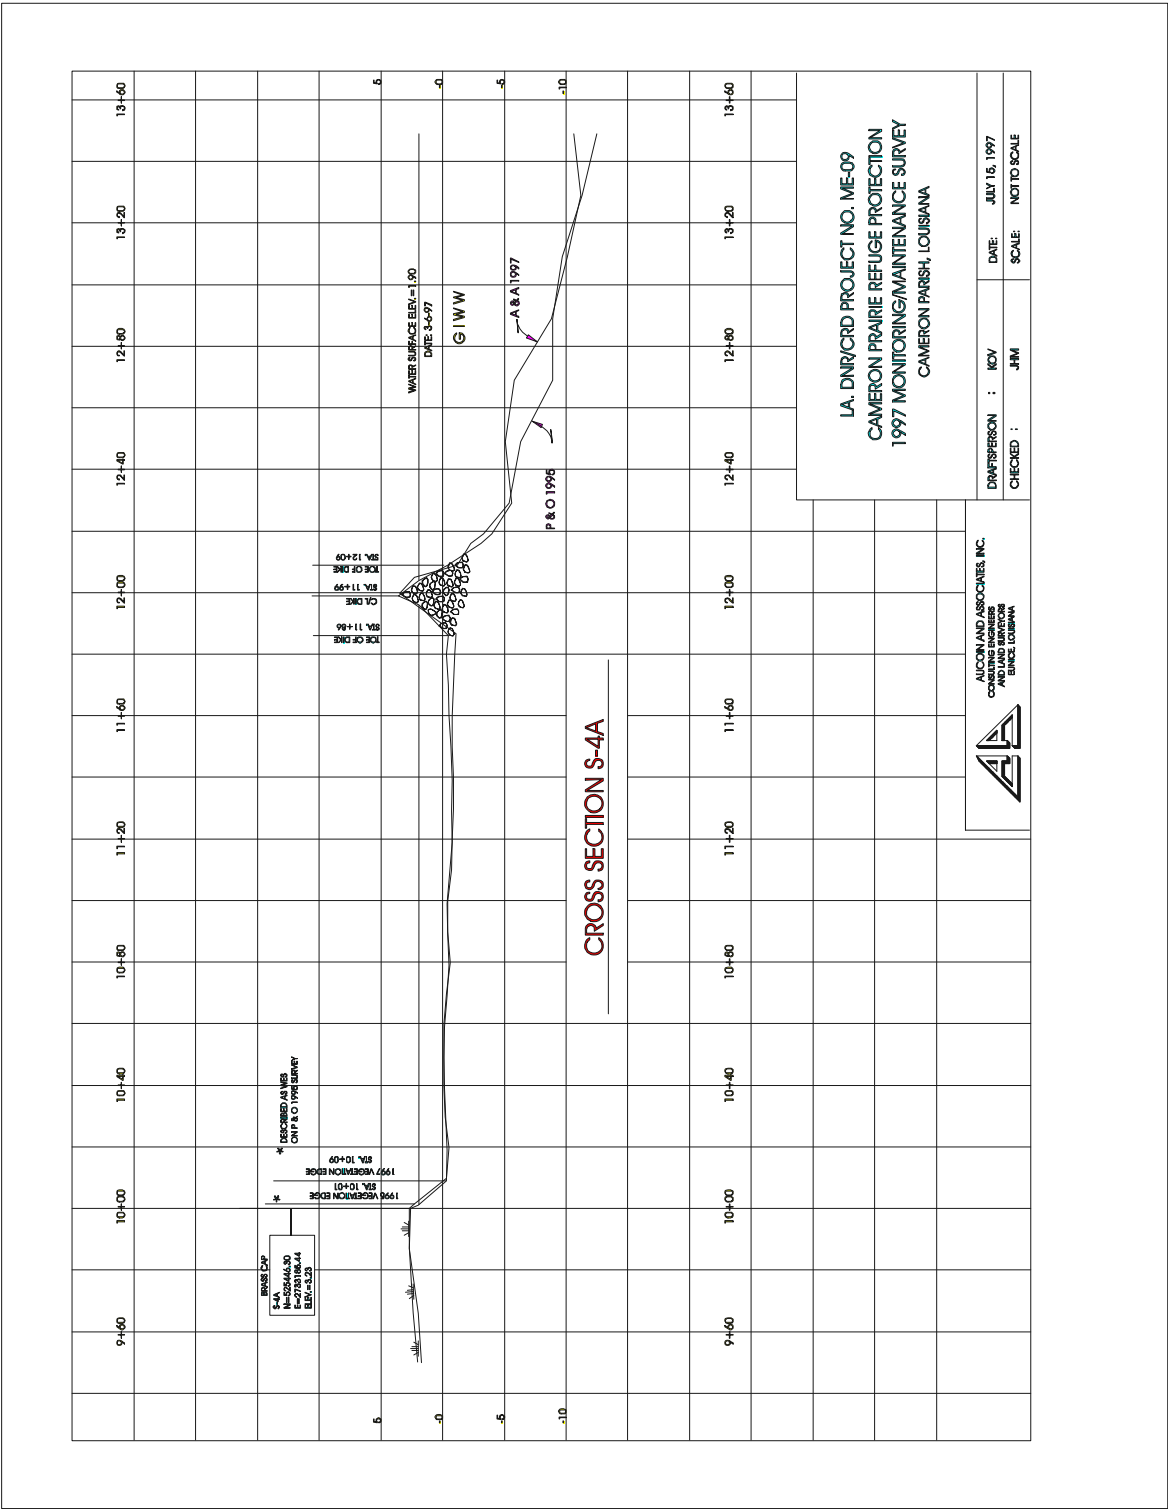
**Figure 7.** Cameron Prairie Refuge Protection (ME-09) cross section S-4A in the project area showing the survey lines, vegetation edge, and channel profile.

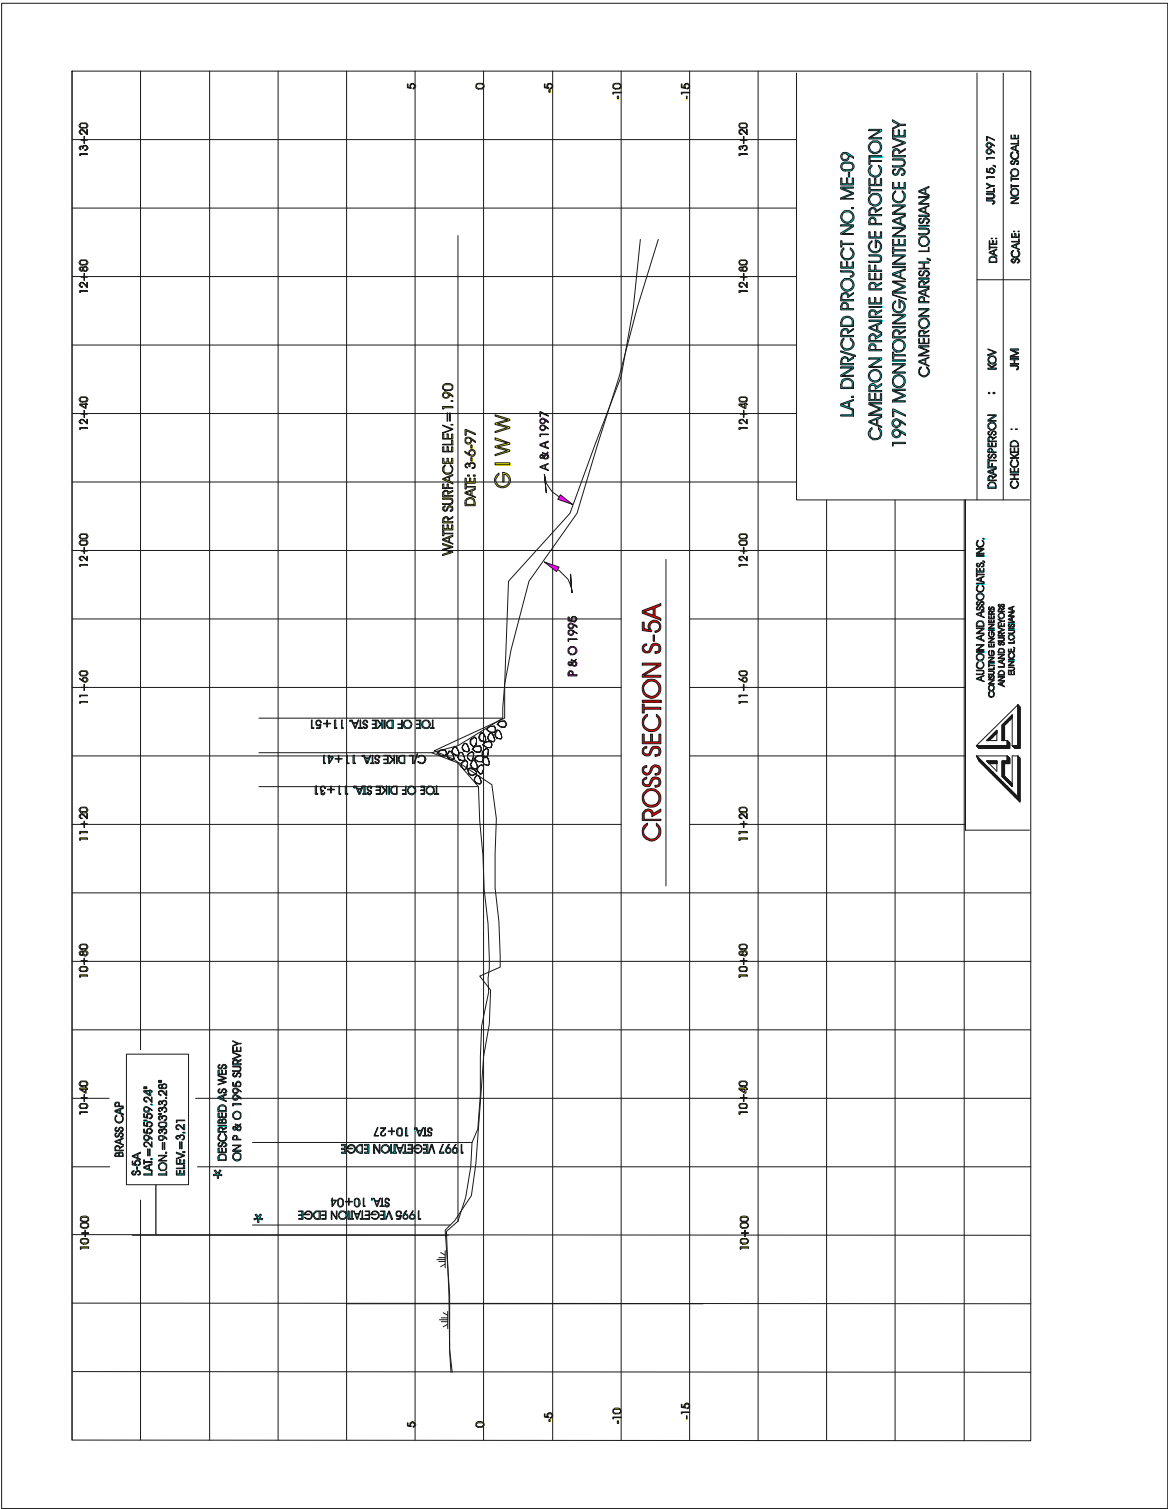
**Figure 8.** Cameron Prairie Refuge Protection (ME-09) cross section S-5A in the project area showing the survey lines, vegetation edge, and channel profile.

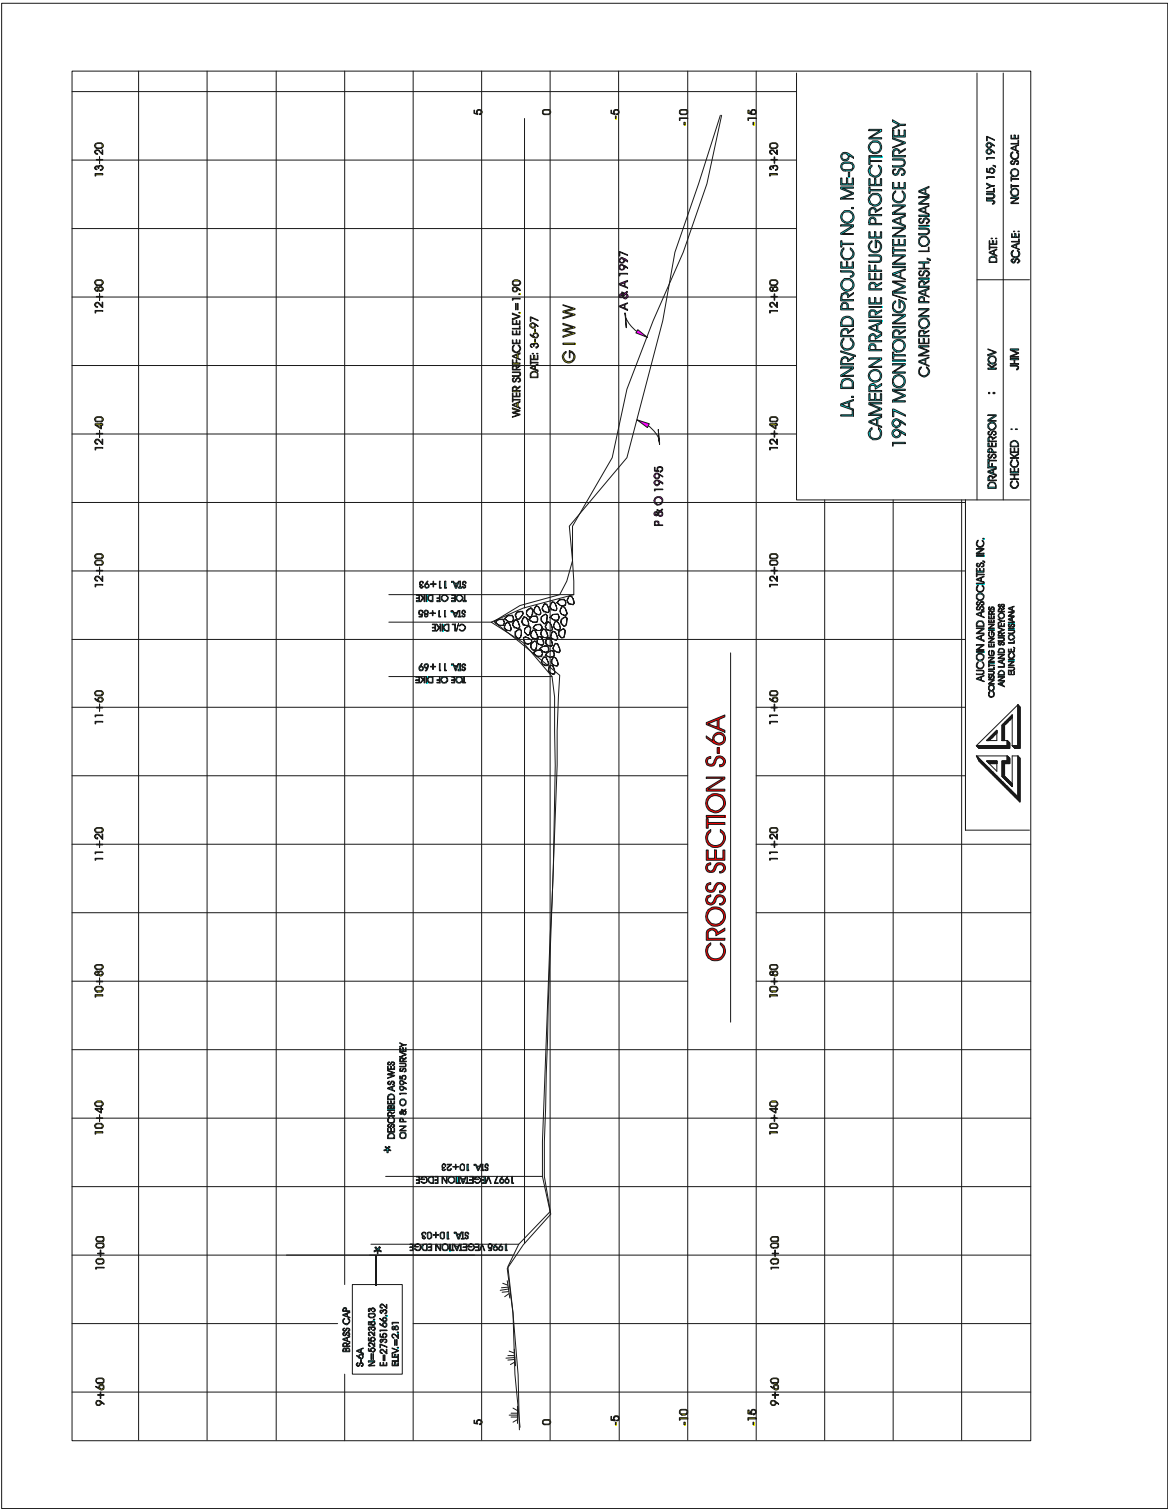
**Figure 9.** Cameron Prairie Refuge Protection (ME-09) cross section S-6A in the project area showing the survey lines, vegetation edge, and channel profile.

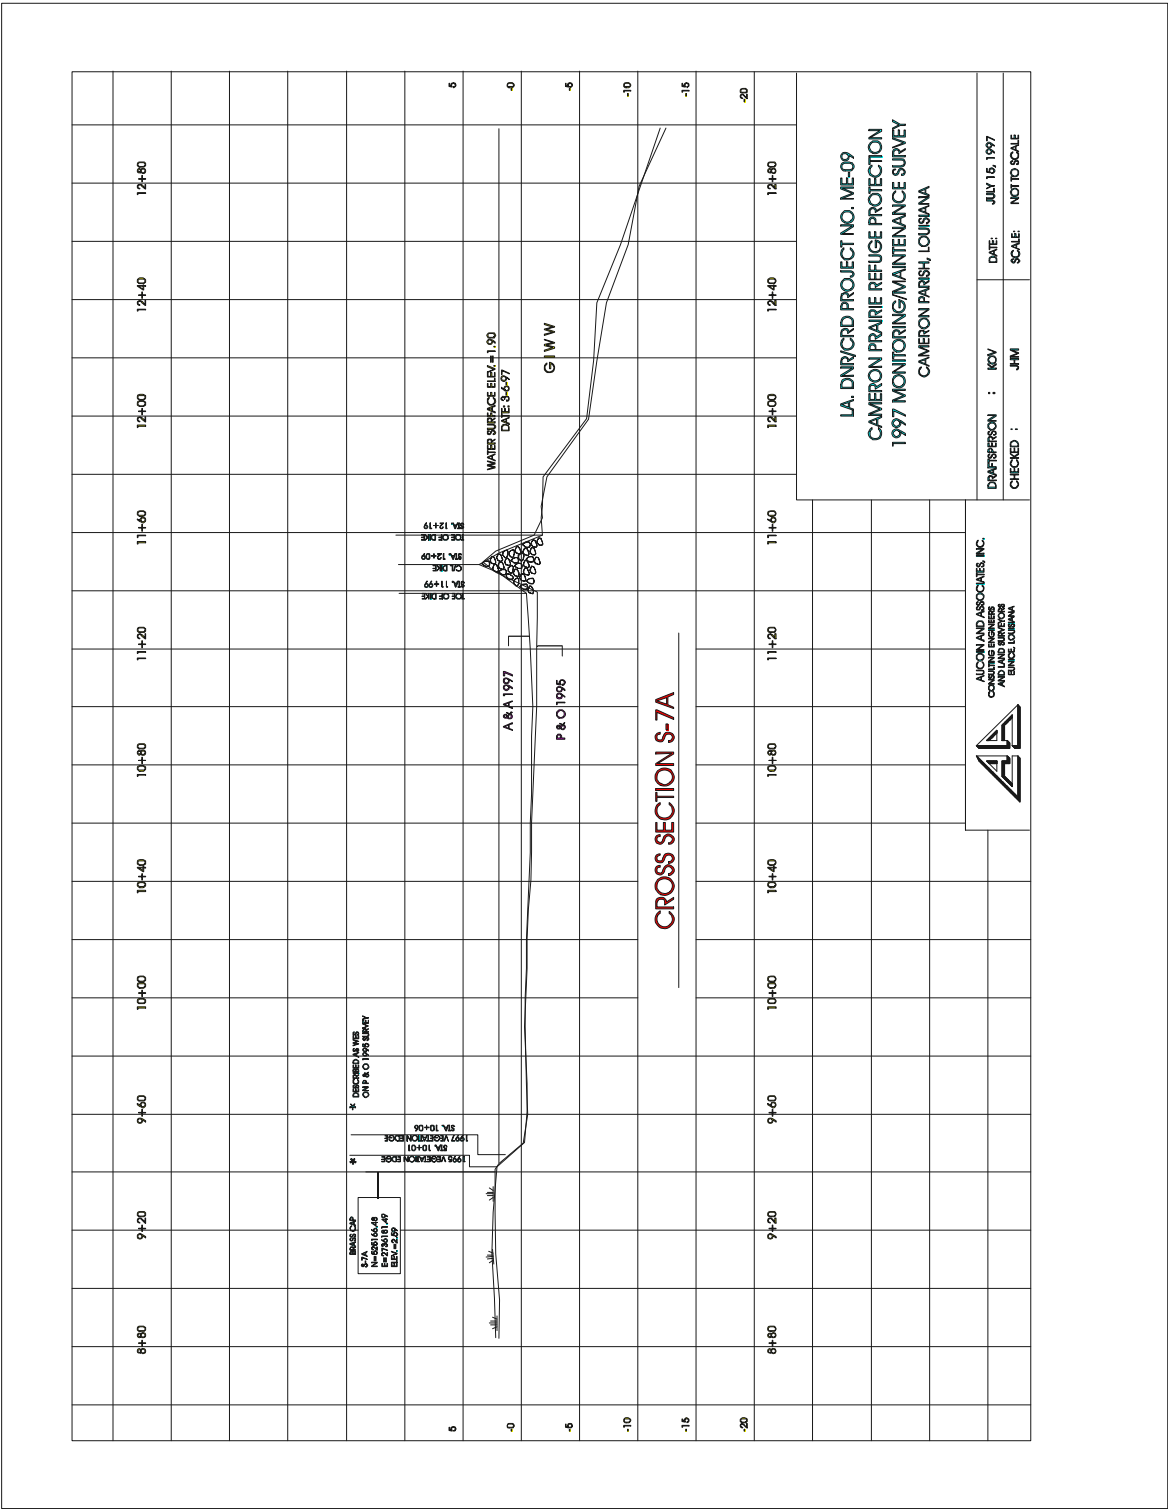
**Figure 10.** Cameron Prairie Refuge Protection (ME-09) cross section S-7A in the project area showing the survey lines, vegetation edge, and channel profile.

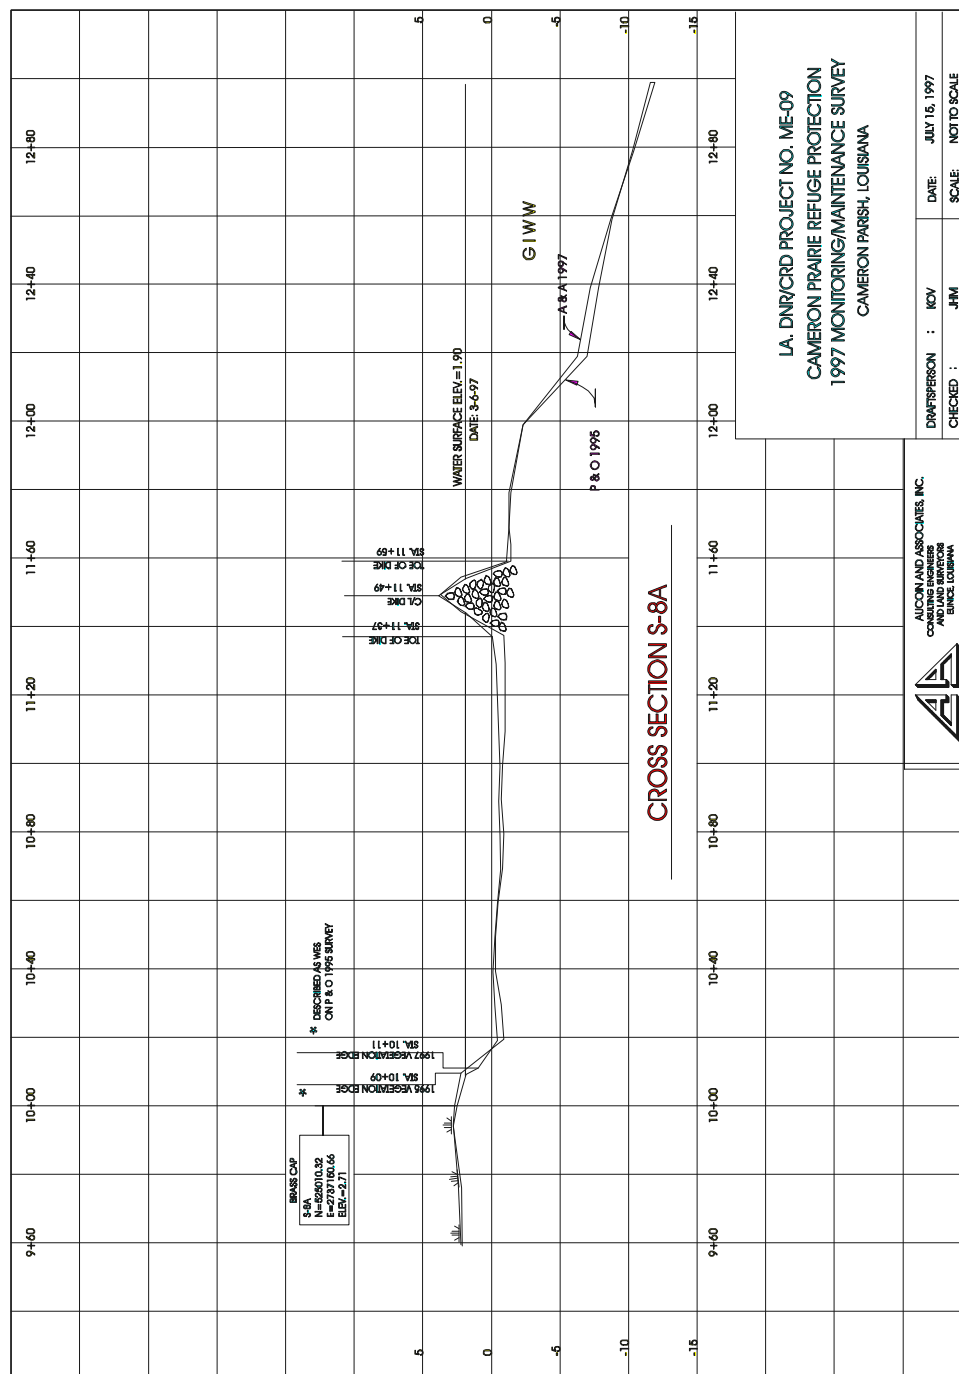
**Figure 11.** Cameron Prairie Refuge Protection (ME-09) cross section S-8A in the project area showing the survey lines, vegetation edge, and channel profile.

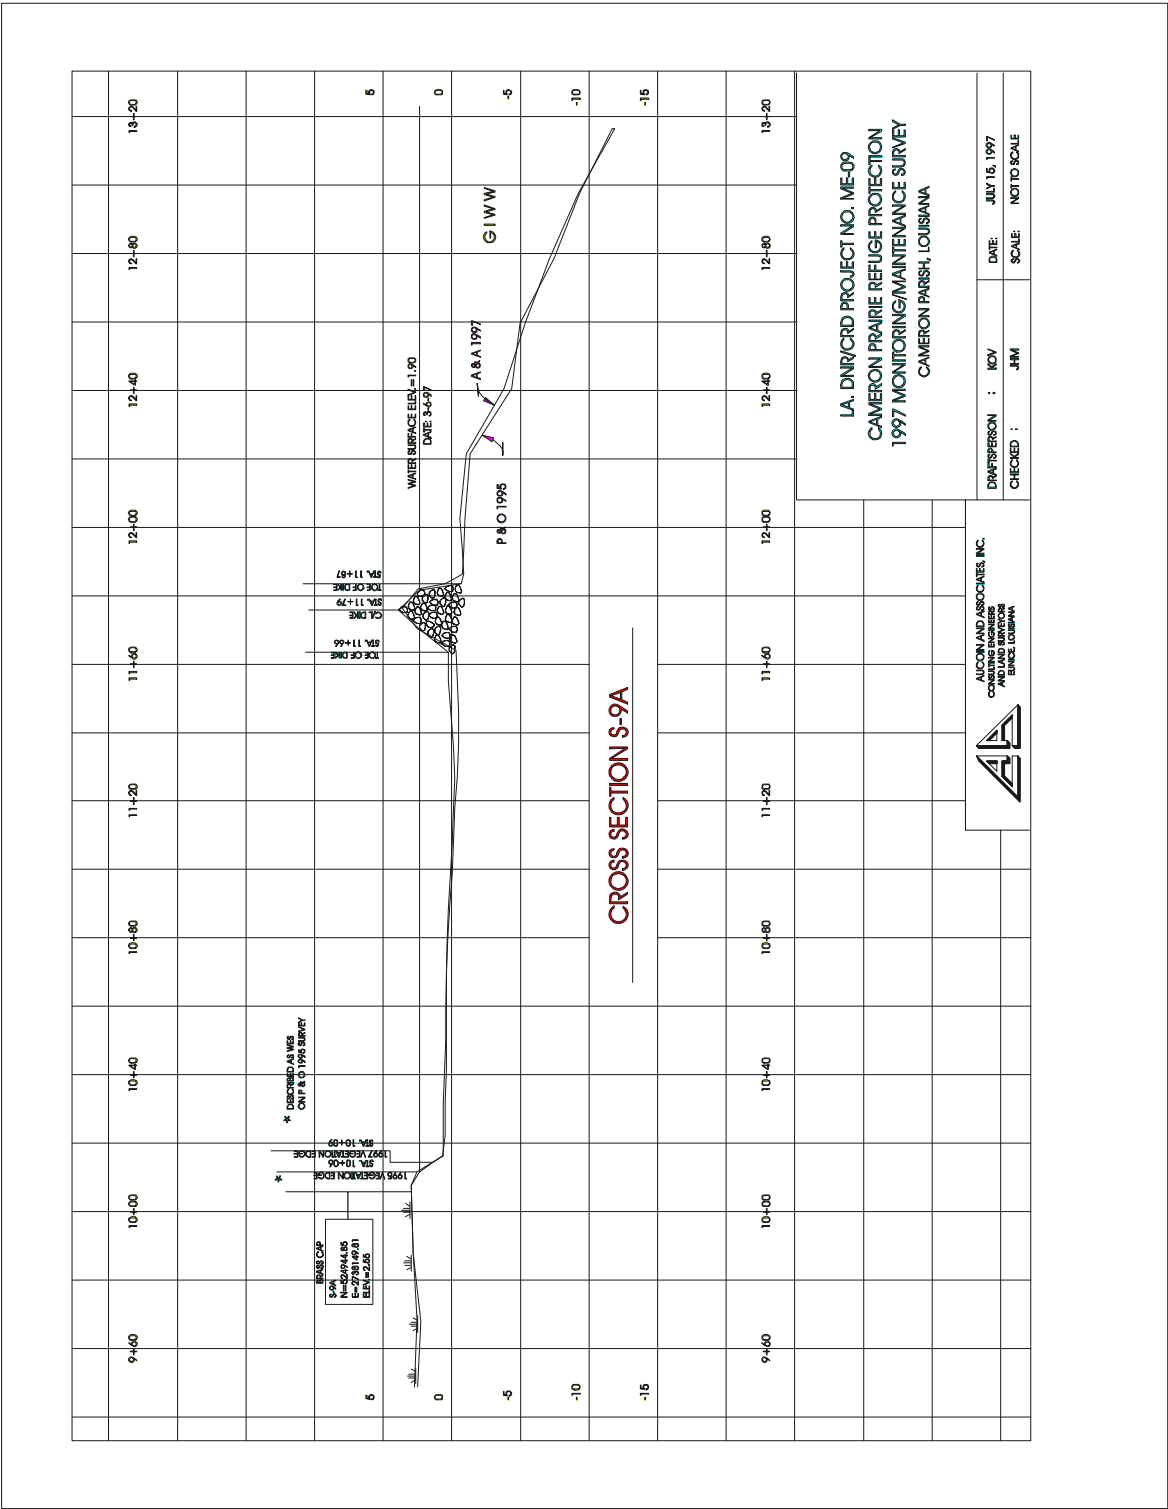
**Figure 12.** Cameron Prairie Refuge Protection (ME-09) cross section S-9A in the project area showing the survey lines, vegetation edge, and channel profile.
